Civil Action No. 20-107-M-DLC-KLD

PARTIAL CONSENT DECREE

Yaak River Bunn Property Floodplain Restoration Design Report and Monitoring Plan

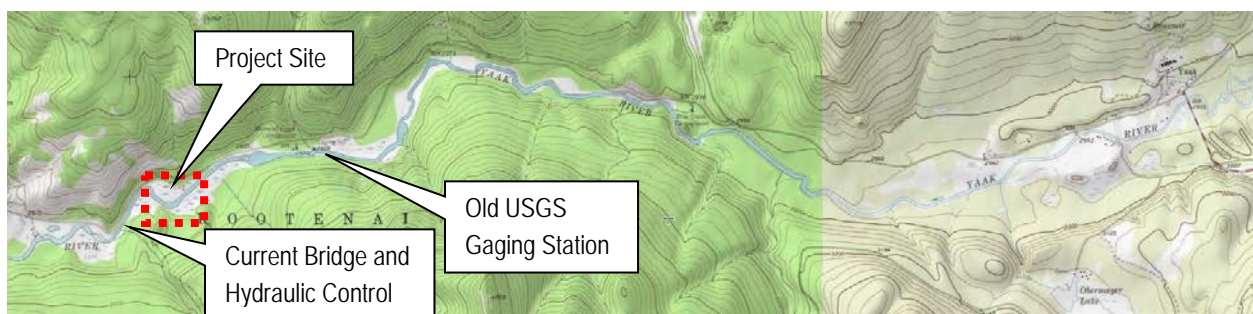
Figure 1. Location of project site, Yaak River near Yaak, Montana. Flow is from right to left.

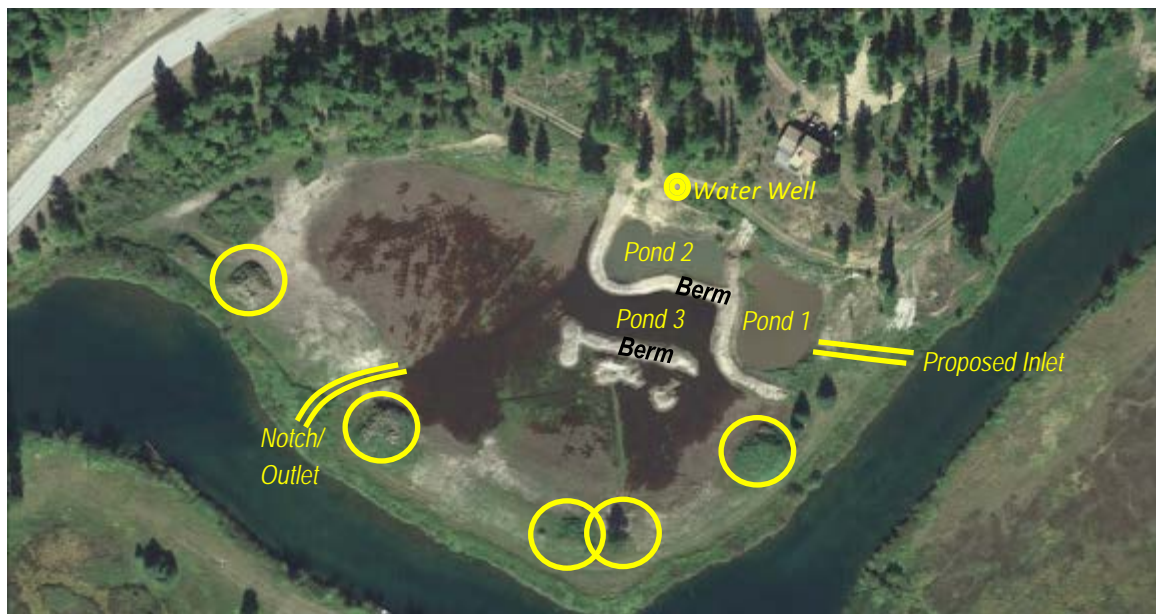
Figure 2. Aerial photographs of site before (2012; top) and after (2014; bottom) floodplain excavation activities. Relevant features referred to in the text are indicated, including historic extent of wetland vegetation inferred from color changes in the aerial photograph, three excavated ponds and surrounding berms, location of outlet connecting the floodplain hydraulically to the river, five main spoils piles (circled), and general location of a proposed high flow river inlet channel.

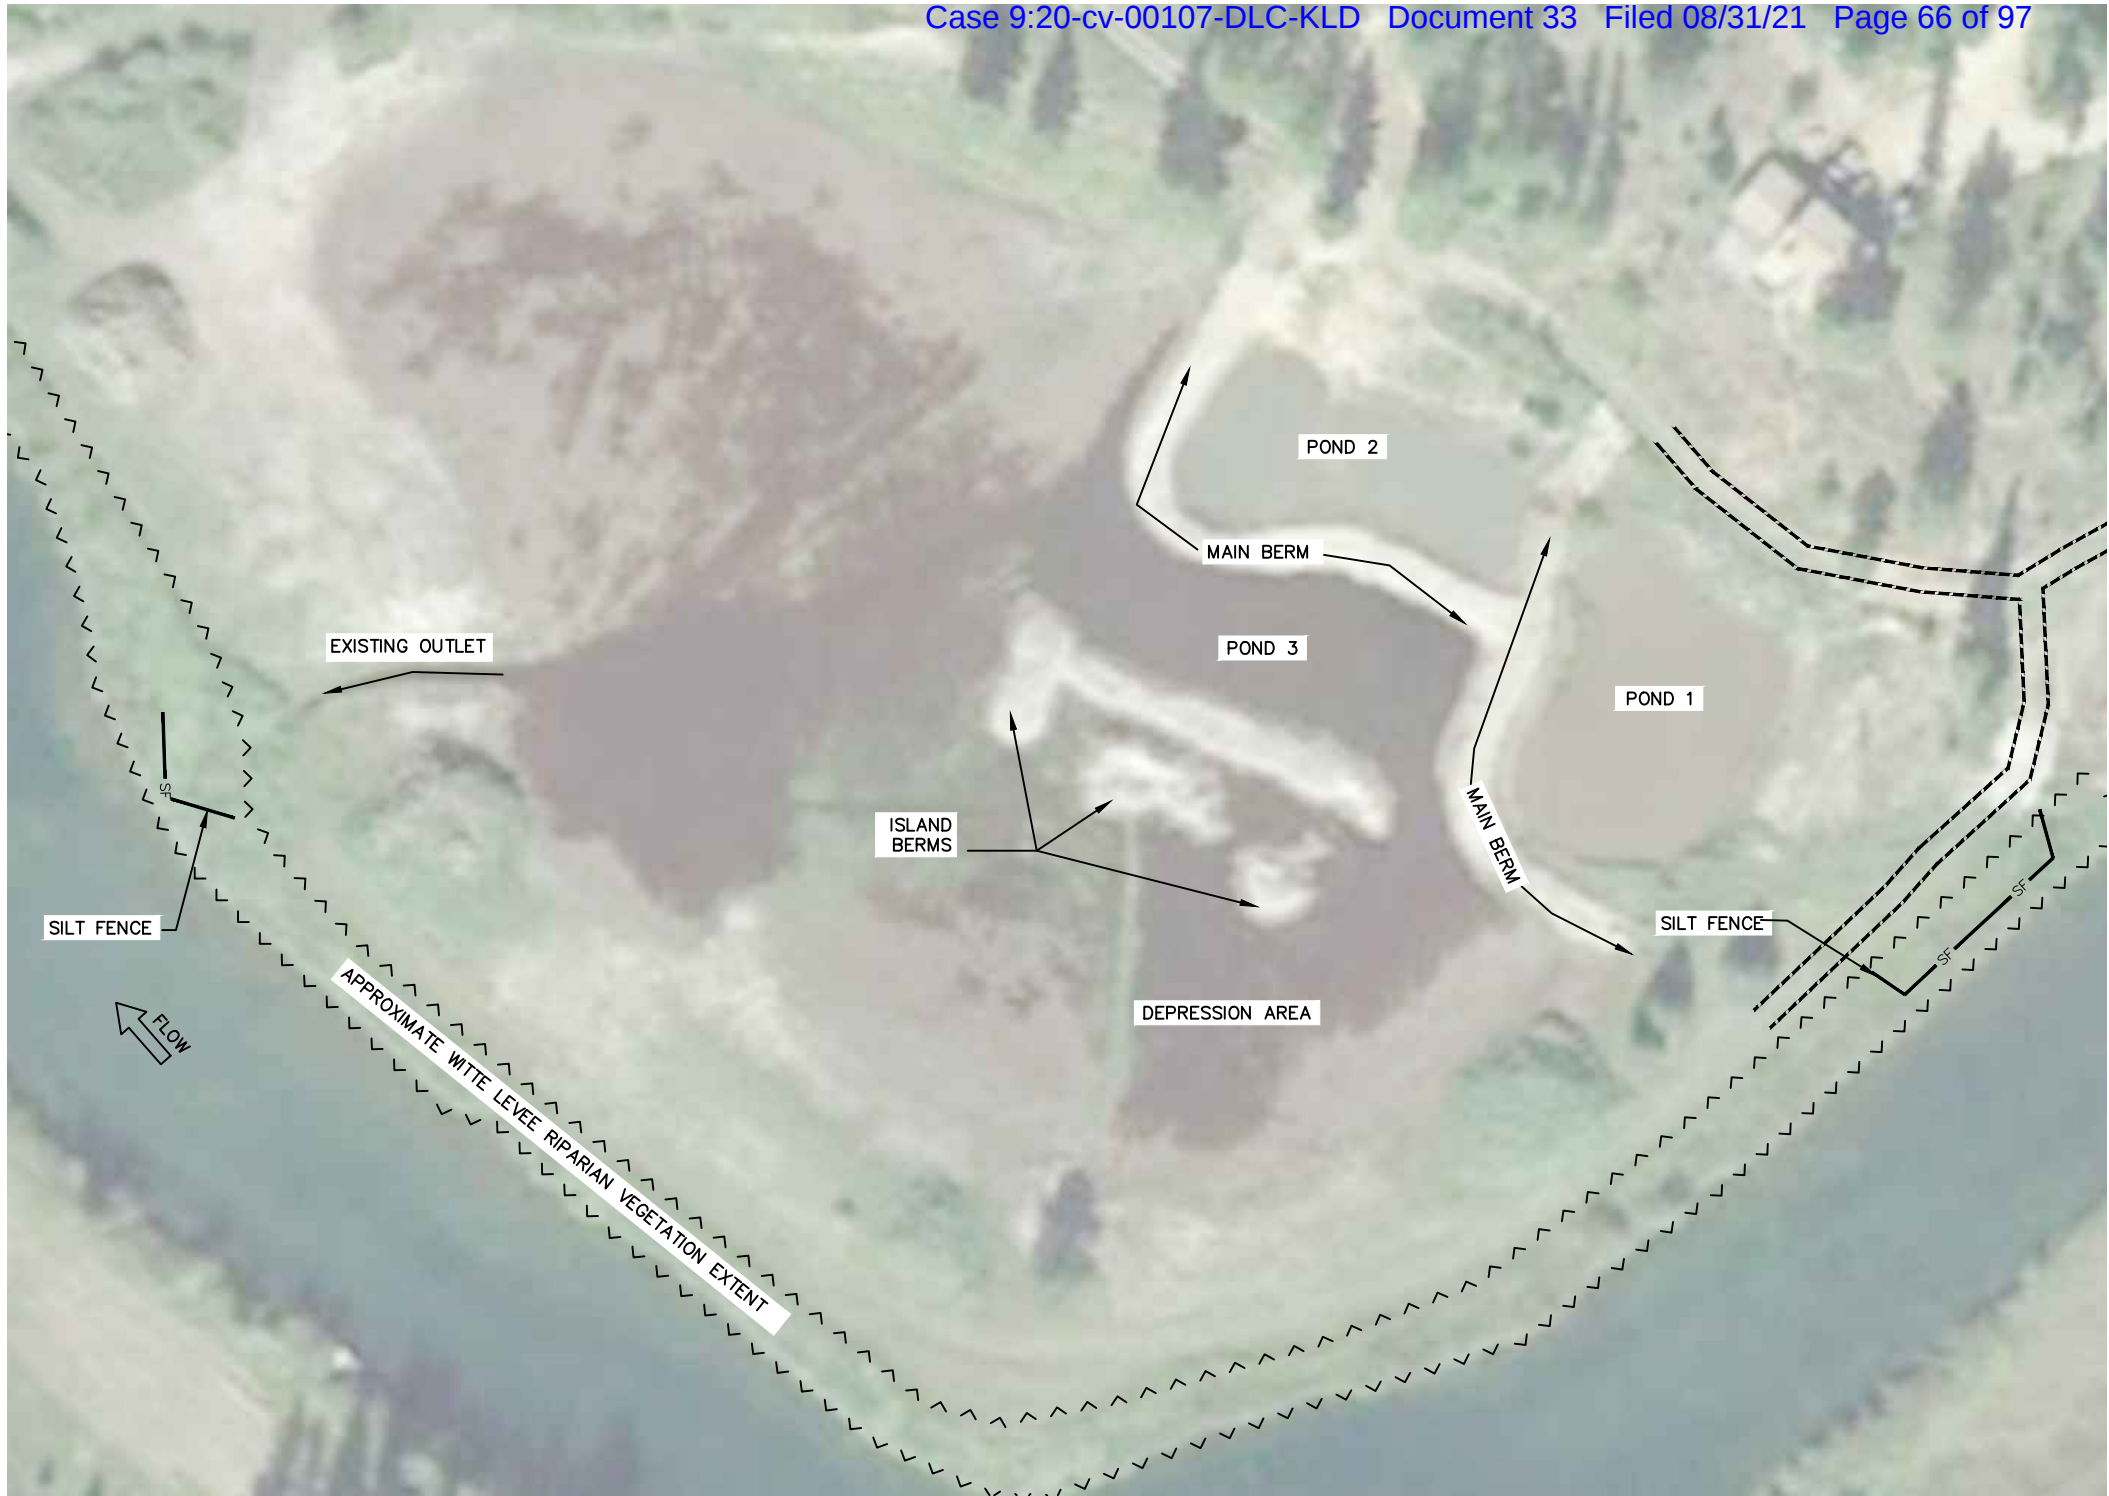
PLAN
CONDITIONS CA. SEPT 2014, BMPS
11
5
80 0 40 80
SCALE: 1"= 80'

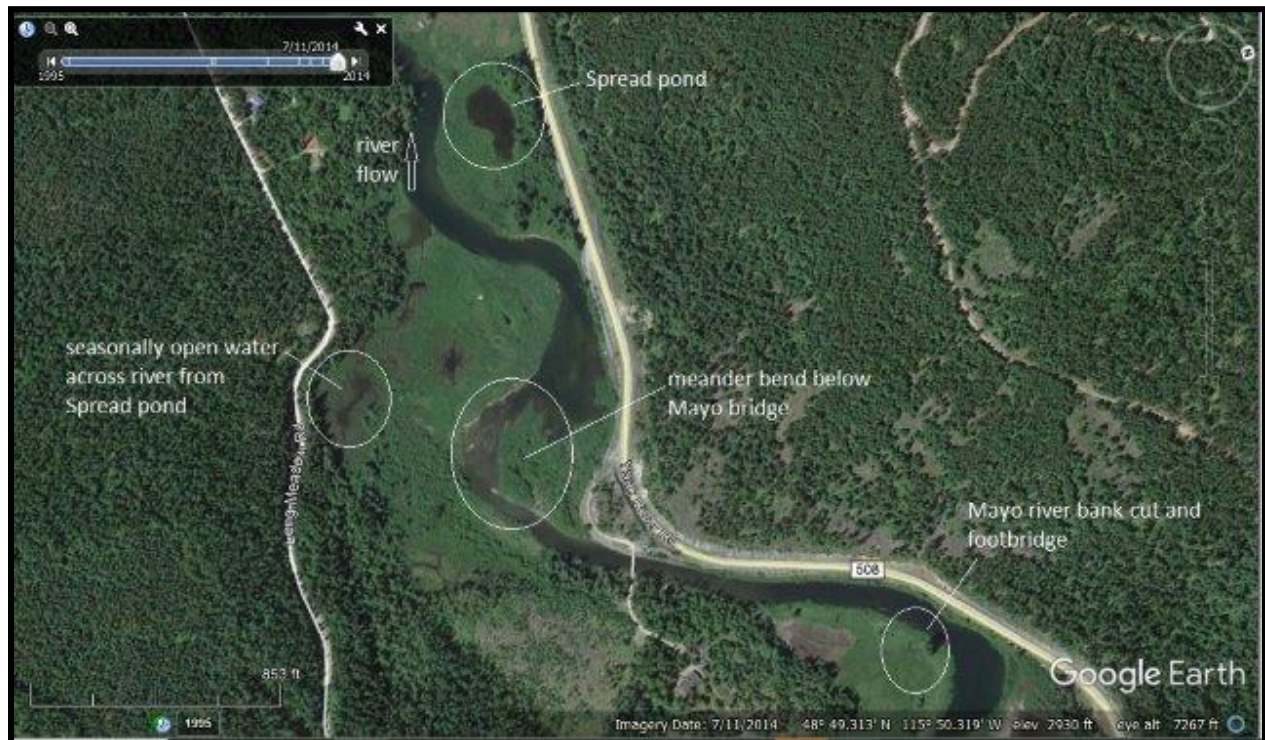
Figure B-2. Reference image showing general Spread pond area immediately downstream from Bunn. View perspective is down-river, to the west. Image date, July 2014.

Reference locations (Figure B-2) in the Spread pond area include the pond itself; a seasonally open water feature upstream, across the river; a higher flow regime meander bend upstream of Spread pond; and a river-bank cut and adjacent wetland floodplain across the river and immediately downstream of the Bunn site.

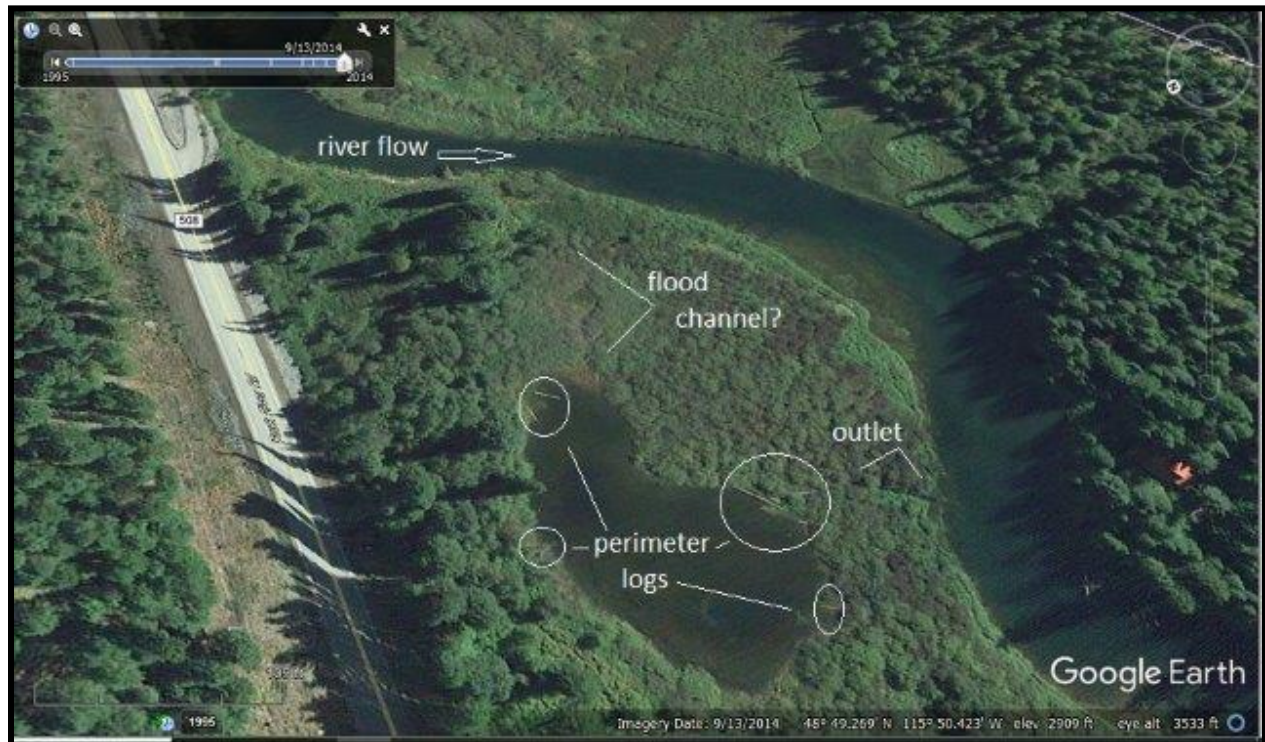
Figure B-3. Spread pond, September 2014. Satellite image shows locations of several logs and wood debris scattered around the perimeter of this open-water feature. Viewing several images acquired in previous years, indicates that most logs are stationary, but some float and move seasonally.

Spread pond, located less than one mile downstream from Bunn site, is a good example of a year-round open water feature. Viewing satellite images over several years, it appears that there have been up to a dozen visible logs and large wood debris objects around the perimeter of the open water (Figure B-3). Some of the logs are not firmly attached and float from time-to-time as evidenced by the variable location of logs in sequential satellite images.

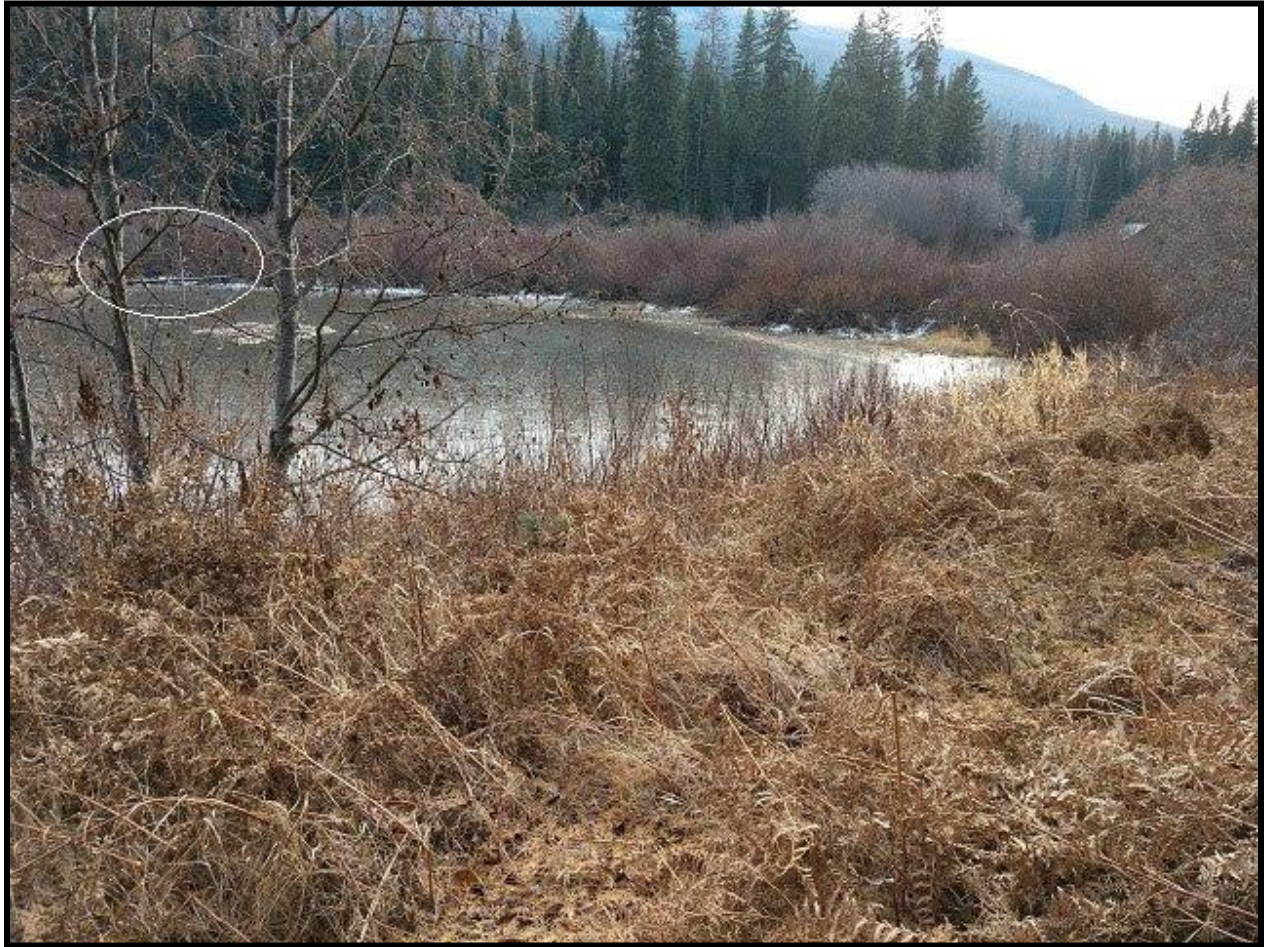
Figure B-4. Ground-level photograph of west-end of Spread pond. Encircled area displays two perimeter logs resting sub-parallel to open water edge. November 2019; view to south.

During a field inspection in late 2019, several photographs (Figures B-4 – B-6) were taken which show the position of select logs at that time (including a recent tree-length blow-down with limbs). At ground level there are partially submerged logs and wood pieces nestled in the heavy brush which are not clearly visible on the satellite images.

Figures B-4, B-5, and B-6 illustrate a number of woody objects, all located around the perimeter of the open water Spread pond.

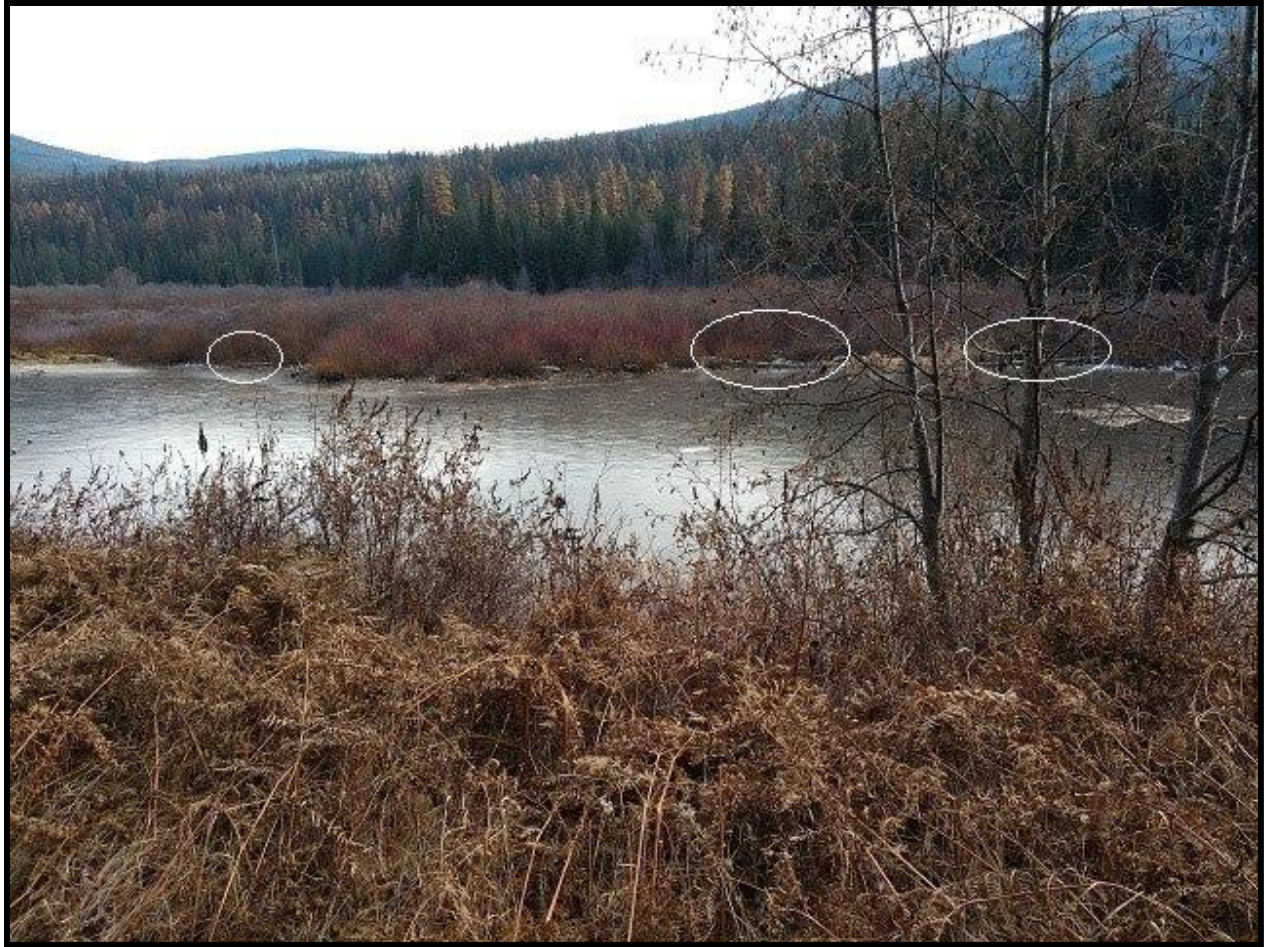
Figure B-5. South view of mid-Spread pond. Encircled wood material (mostly log pieces) around perimeter. November 2019.

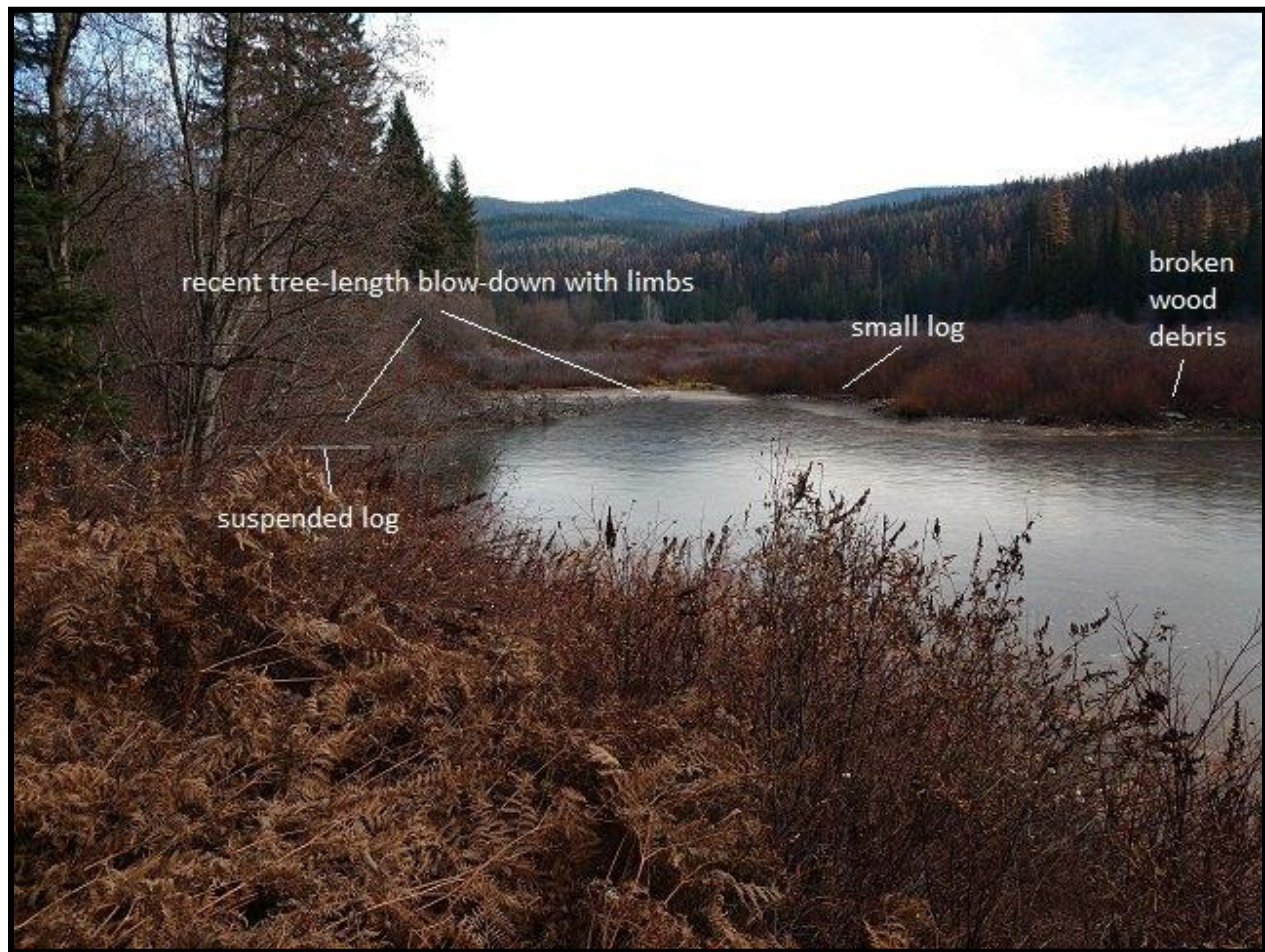
Figure B-6. Up-valley, east view. Wood objects include logs and debris along opposite open water perimeter as well as oblique blow-downs along foreground edge. Note recent tree-length blow-down with limbs. November 2019.

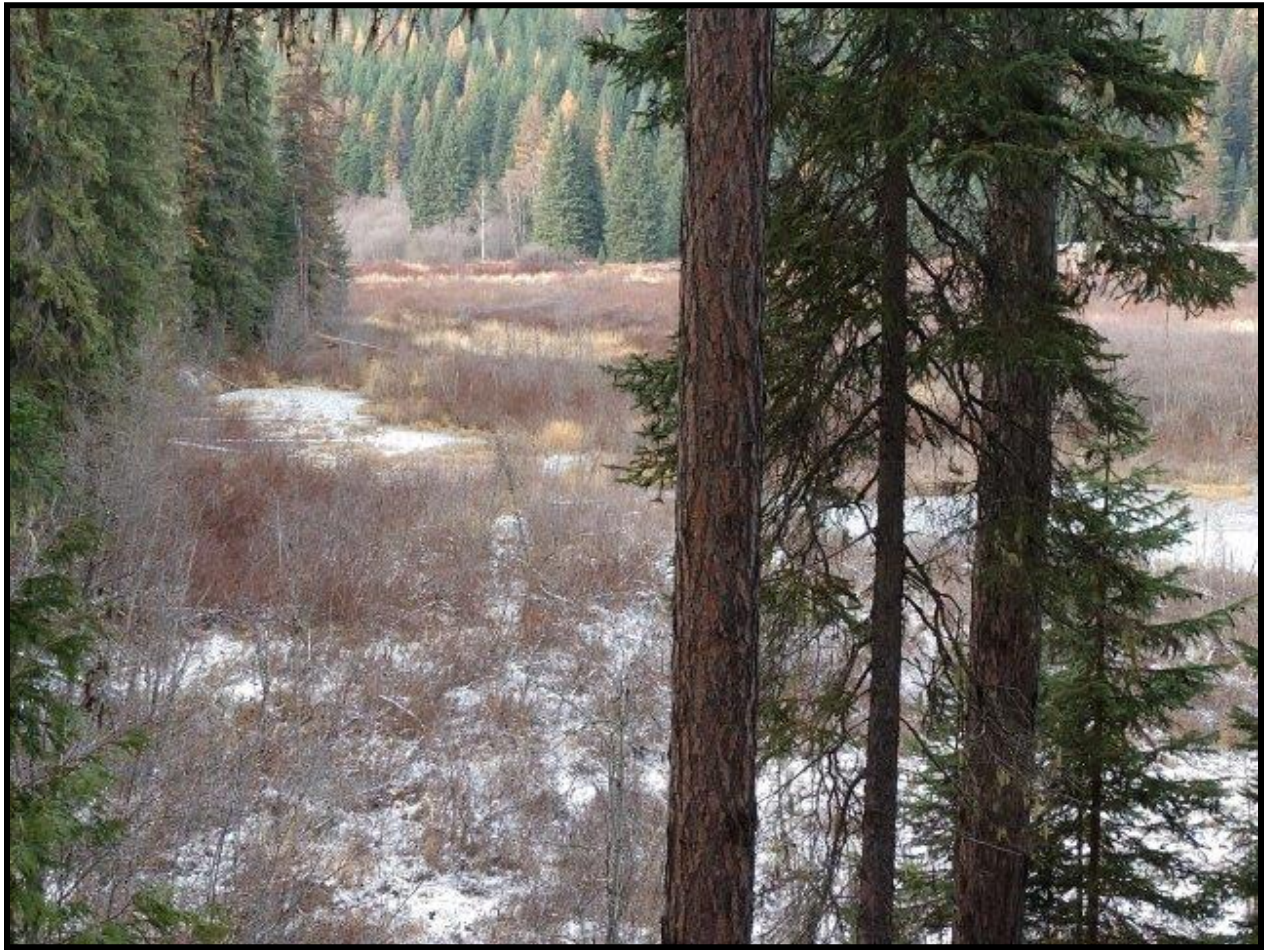
Figure B-7. Seasonally open water feature across river from Spread pond. View is down-river direction. Note scattered blow-down logs from the upland to the base of slope wetland. November 2019.

Across the river from Spread pond (see reference Figure B-2) is a seasonally open water area that also contains a few scattered logs which appear to be blow-downs from the adjacent hillside. A photo (Figure B-7) from the road on that side of the river illustrates the size and relative position. Since the open-water areas do not receive amounts of surface water sufficient to float and transport the logs, they are ordinarily perpendicular; or, at an oblique angle to the hillside from which they fell.

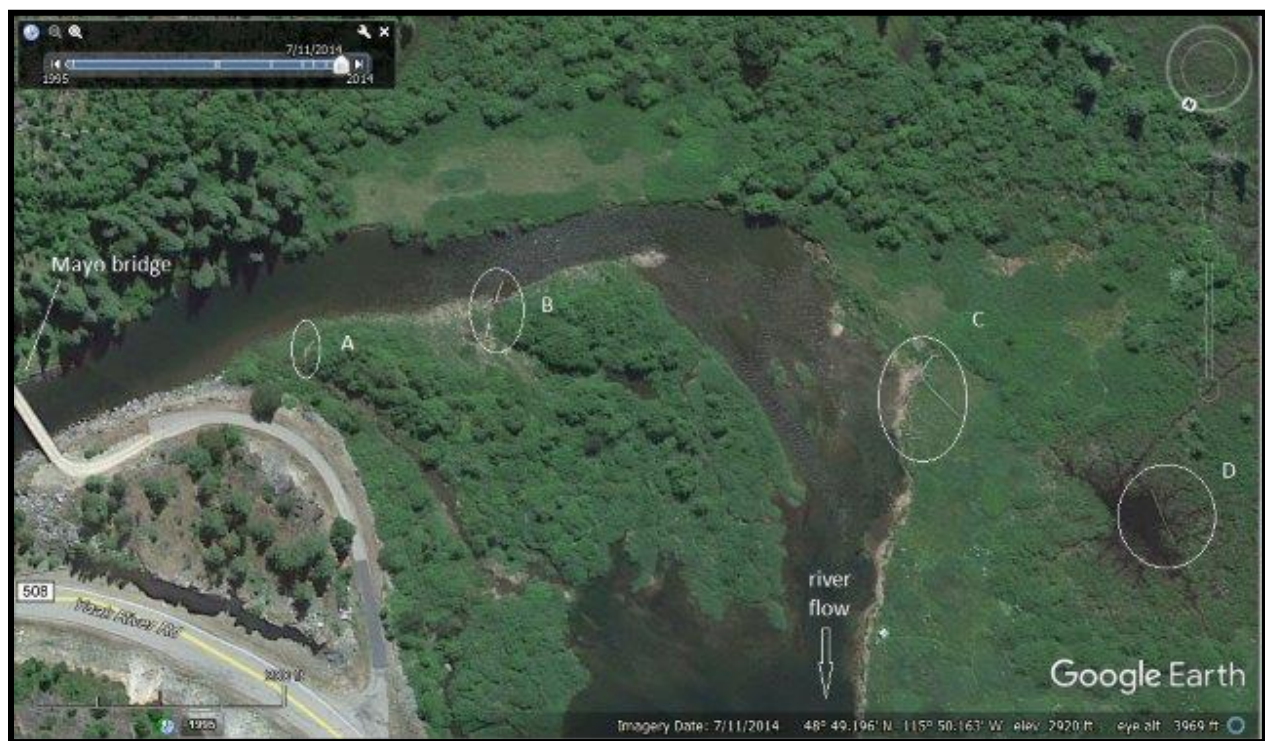
Figure B-8. Various river-rafter logs shown (A, B, C, D) along portions of meander bend. July 2014 satellite image.

On the meander river bend, located just upstream of Spread pond, below the Mayo bridge (Figure B-8), logs carried by the river during flood stage are shown to have lodged near the head of two cut-off channels (A and B in Figure B-8). At the outer, downstream curve of the bend, a cluster of river drift logs are shown strewn sub-parallel to the stream flood direction (Figure B-8, C). One of the larger logs appears to have been rafted onto the floodplain at the river bank; another, appears to have been carried into a seasonally open-water feature (D in Figure B-8). Although these examples of large wood debris are transported in a higher gradient flow regime and may not be expected on the elevated floodplain along the low-gradient reaches which characterize the Bunn site, the size and orientation of wood may help in considering the planform of channel-type material during restoration.

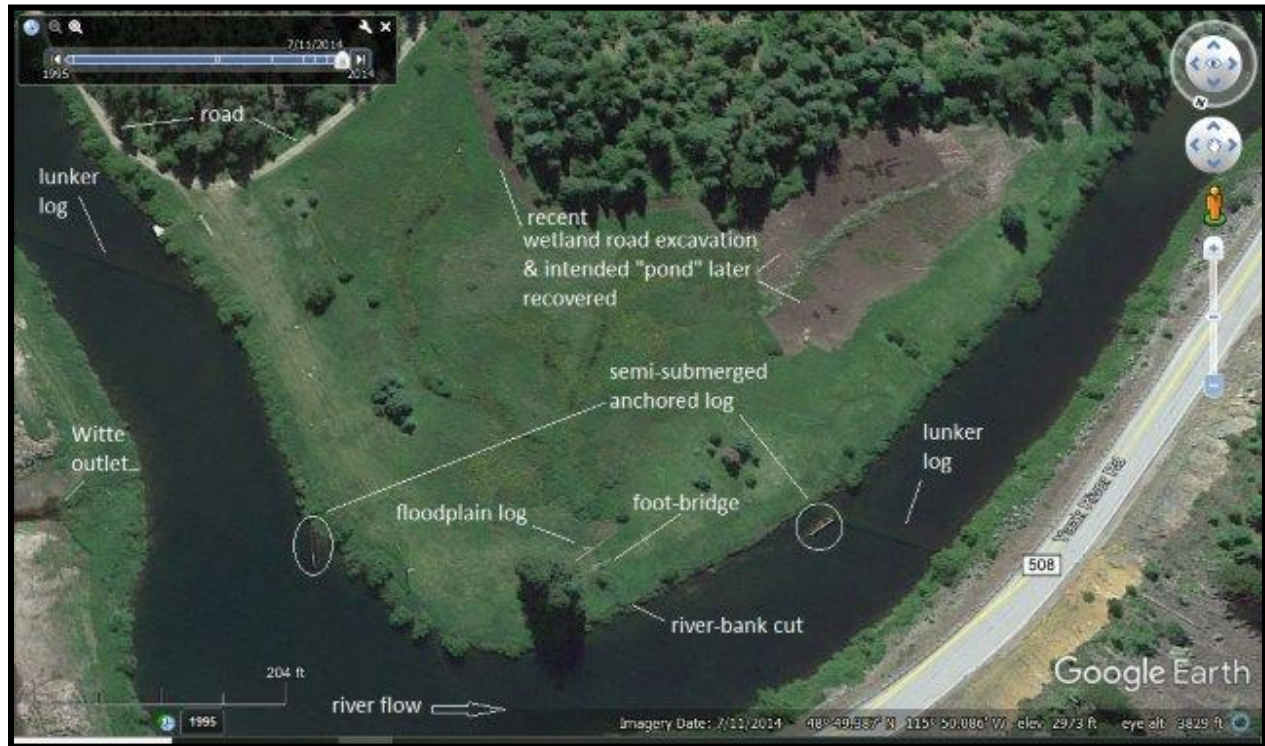
Figure B-9. July 2014 satellite reference image. Wetland floodplain is located immediately across, and downstream, of the Bunn site...indicated by Witte outlet annotation.

Immediately upstream of the Mayo river-bridge; and, across the river, downstream of the Bunn site, is a wetland floodplain connected to the river by a river-bank cut. Figure B-9, is a satellite image illustrating semi-submerged, anchored logs along the Yaak River, submerged river “lunker” logs, and a floodplain log lying across the bank channel cut.

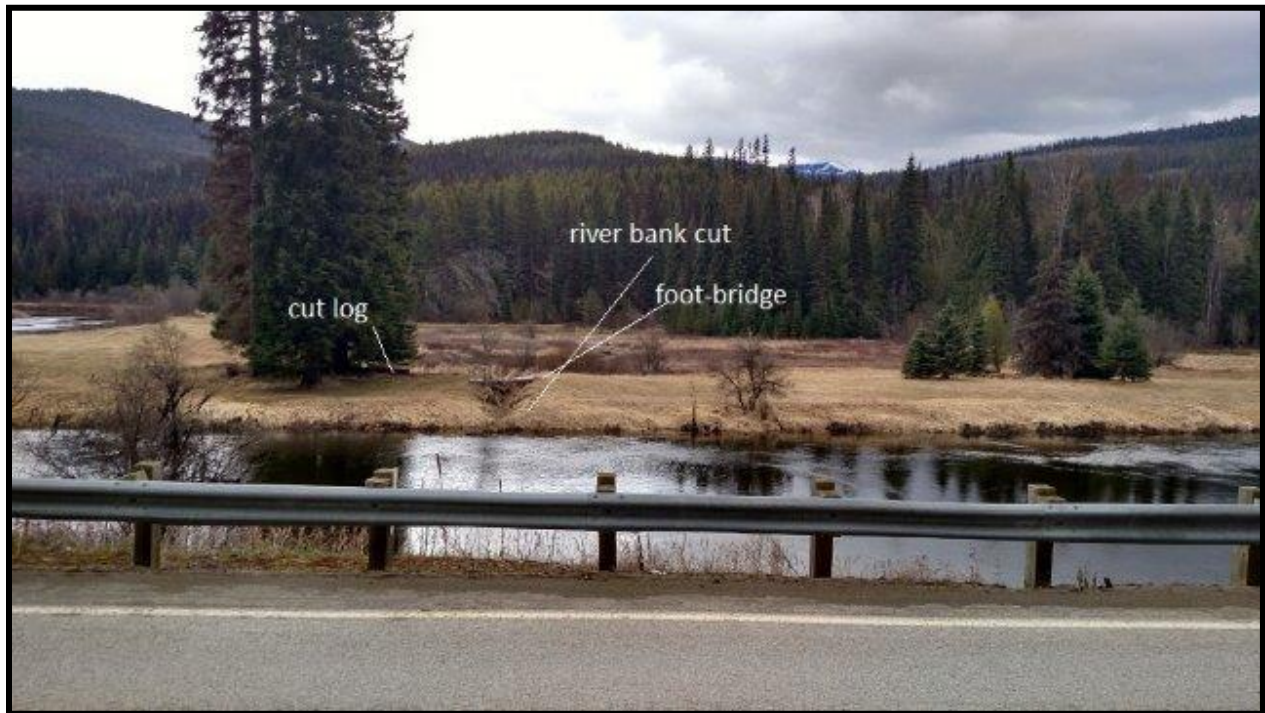
Figure B-10. Southeast view from Yaak River Road shows river-bank channel cut and floodplain log. Late April 2019 photo was taken in higher river flow time before highest flood levels. Semi-submerged anchored river log is barely visible as a surface ripple on right, down-river.

The photograph in Figure B-10 shows the river-bank cut and footbridge (annotated in Figure B-9) across the river, downstream of the Bunn site.

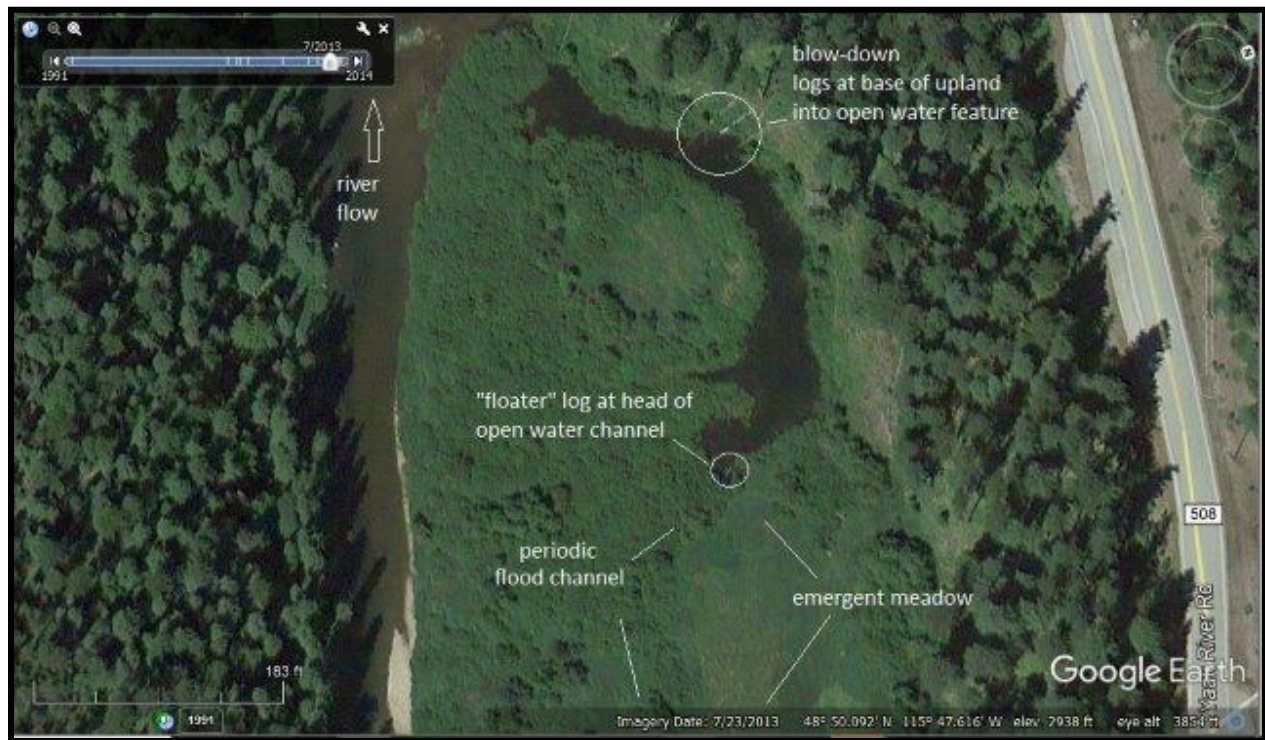
Figure B-13. Encircled log on perimeter of open water is likely sourced from local blow-down from adjacent upland.

Figure B-13 is a zoomed satellite image illustrating the size and position of a log located near the head of the open-water channel feature.

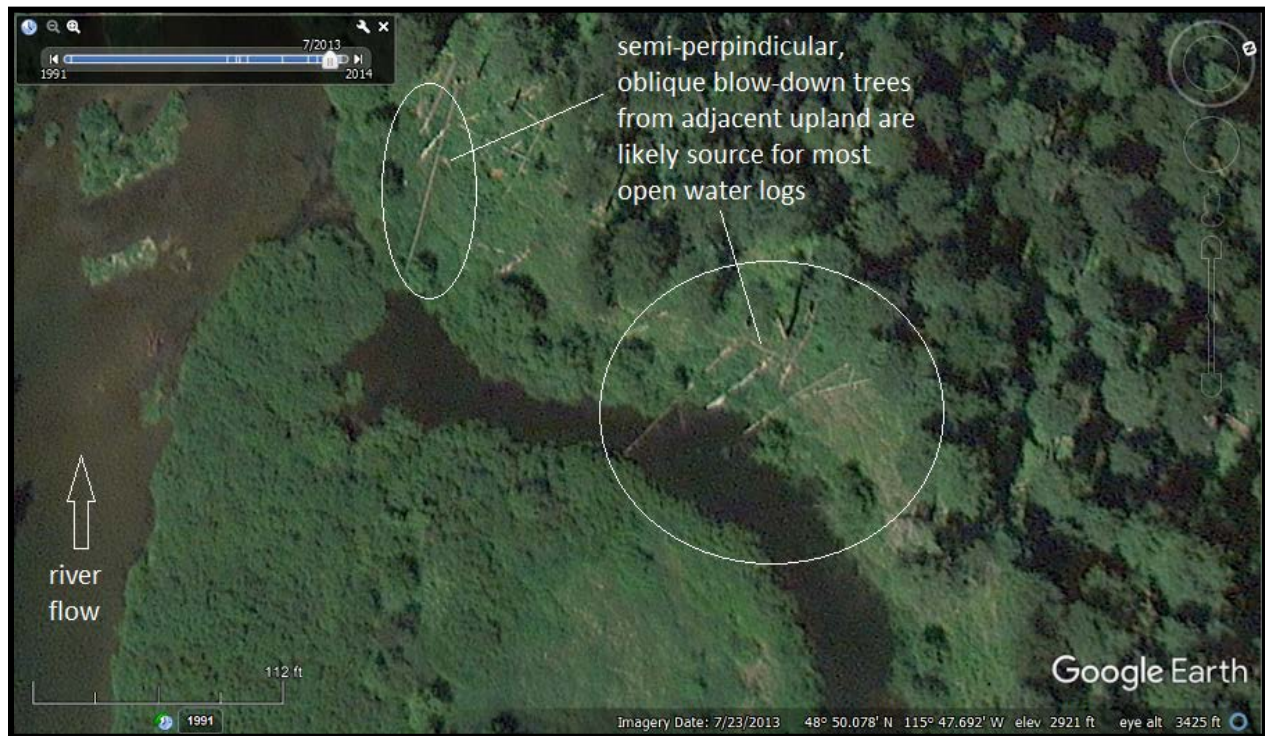
Figure B-15. Lower end of Elk Point meadow/channel complex.

Figure B-15 is a zoomed satellite image demonstrating fallen trees from the upland into the open water channel feature. Broken pieces of these blow-down trees contribute log sources and debris to the base-of-slope feature

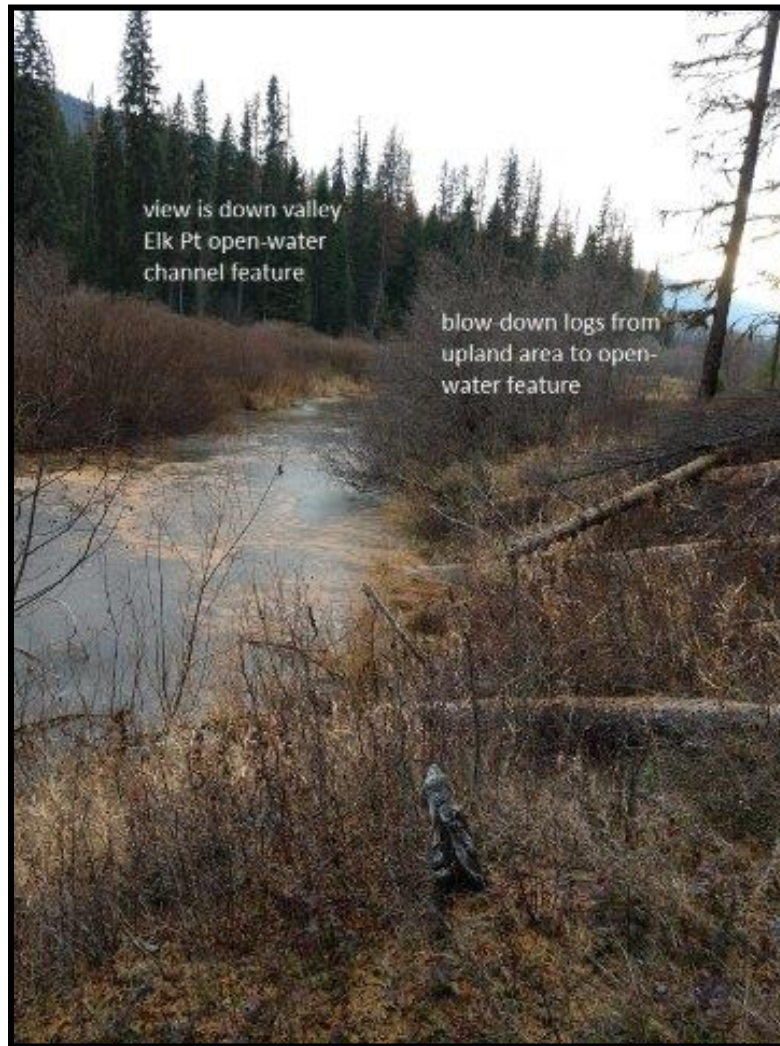
Figure B-16. November 2019 photograph along Elk Point meadow/channel complex. Log pieces from fallen upland trees create more complex habitat.

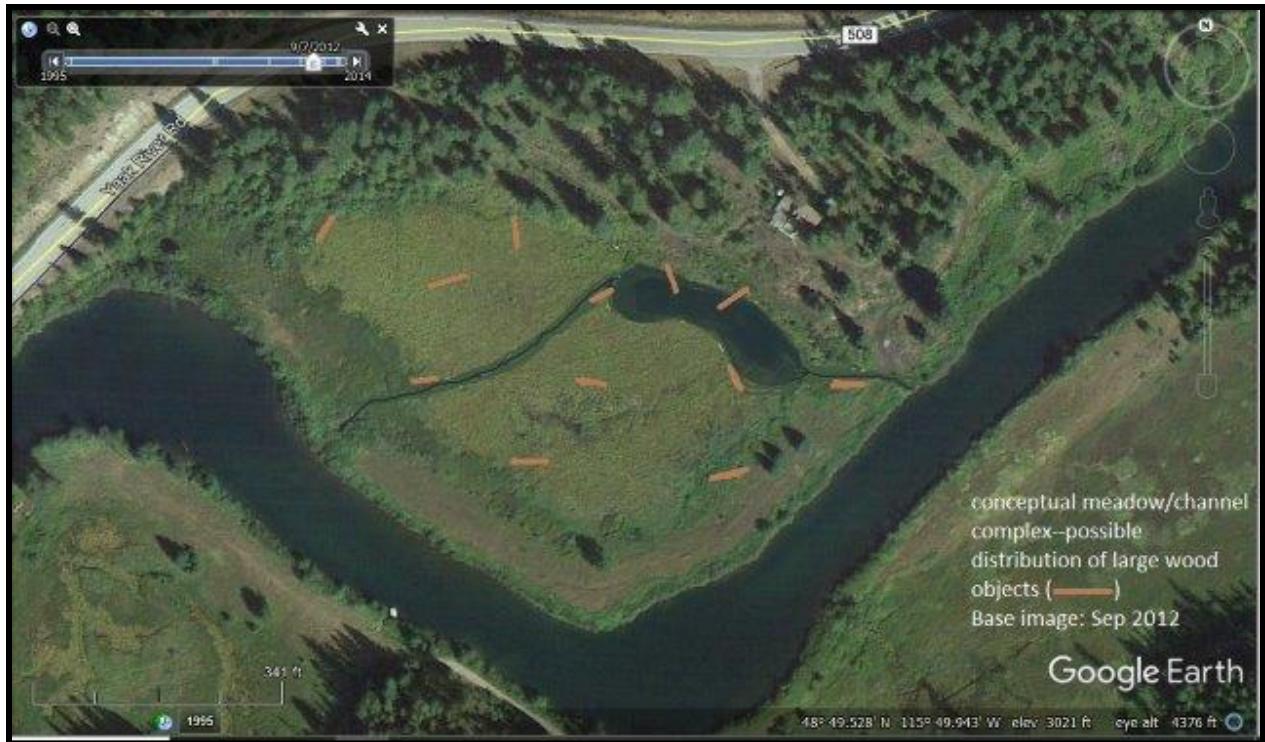
Figure B-21. Conceptual view of wood material distributed across restored Bunn site. This image was created with Microsoft Paint program utilizing the September 2012, satellite image as a background. The proposed upstream inlet channel is shown; along with, the open-water channel feature and outlet swale to the downstream river drainage notch.
